# BELZONA SUPERWRAP II REPAIR OF REFINERY PIPE

ID: 8085

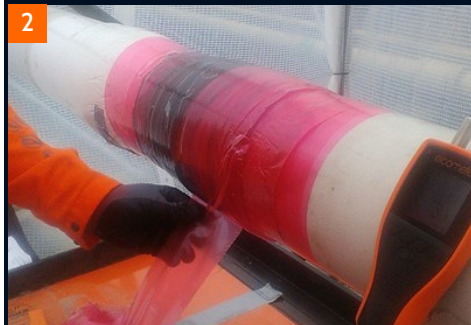
1. Plated bonded with Belzona 1212
2. Application of consolidation tape
3. View of finished Superwrap II application
4. View of finished Superwrap II application

A 20x20mm pre-fabricated plate was bonded into position followed by the Belzona Superwrap II system. The application was completed in accordance with Belzona system Leaflet VPF-11 following the Belzona Superwrap II design.
