# BELZONA REPAIRS PUMP CAISSONS

ID: 8088

Pump caisson pipe suffering from external corrosion and through-wall defects

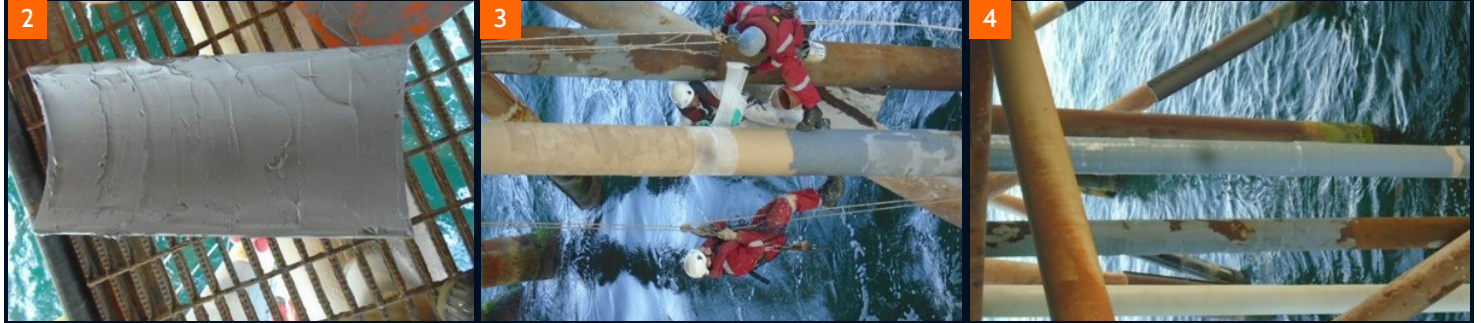
Through wall defects of pipe causing leakage of water with large areas of pitting.

1. Defective pipe
2. Doubler plate
3. Belzona 5831 1st coat
4. Belzona 5831 2nd coat

The application was completed in accordance with Belzona System leaflet VPF-11 and SOS-21. Through wall defects were repaired by plate bonding using Belzona 1212. Pitting was repaired with Belzona 1161 followed by 2 coats of Belzona 5831 with Reinforcement Sheet between the coats.
