# BELZONA BATCH MIXER LINING

ID: 8089

New fabricated batch mixer lining for a food production facility by Belzona.

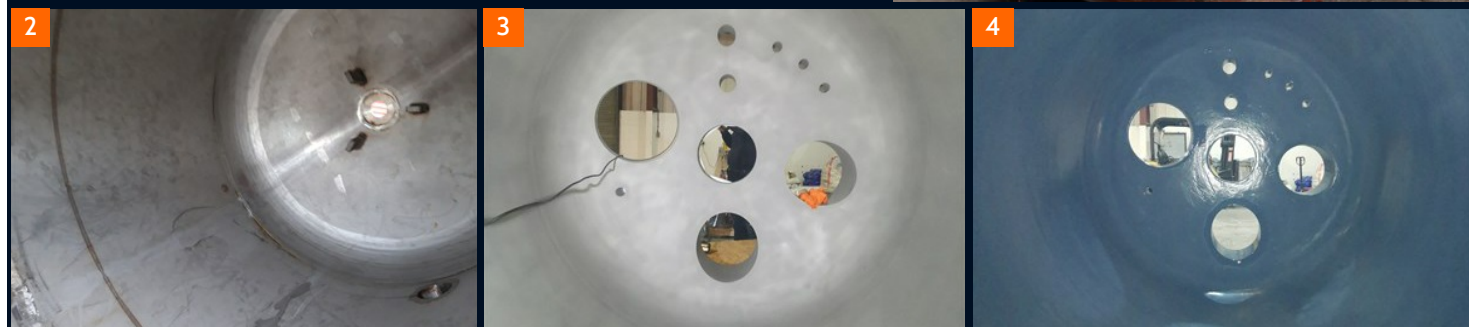
## PHOTOS

1. The vessel being transported into the Belzona Technosol workshop, ready for work to begin.
2. The inside of the vessel before being cleaned and blasted, ready for the coating.
3. The first coating of Belzona 1321 Grey
4. The finished application, after the second coating of Belzona 1321 Blue.

The vessel was grit blasted to SA2.5 at 75 $\mu$ , then lined with the first coat of Belzona 1321 to the required thickness, at the recommended coverage rate of (1.14 m<sup>2</sup>)/kg in accordance with Belzona Know How System Leaflet VPF-02. Due to the dimensions of the tank, a brush was used for the application. The second coat was then applied, and allowed to cure overnight.
