# CLOSED DRAIN VESSEL PROTECTION USING BELZONA 1591

ID: 809

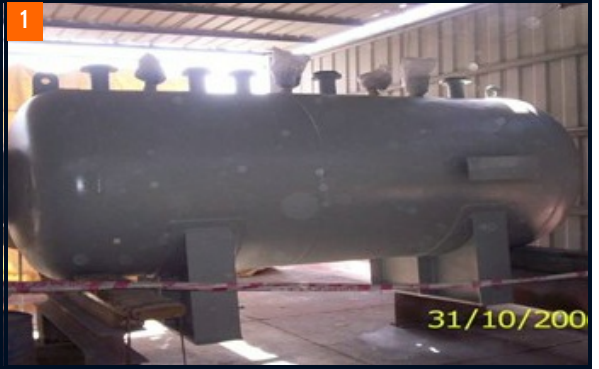
1. General view of the vessel
2. Applying Belzona 1591 to the vessel
3. Sleeves made from Belzona 1511 to protect the nozzles
4. Vessel Protected
