# BELZONA 1321 IN USE AT A LARGE SAWMILL IN THE BALTICS

ID: 8093

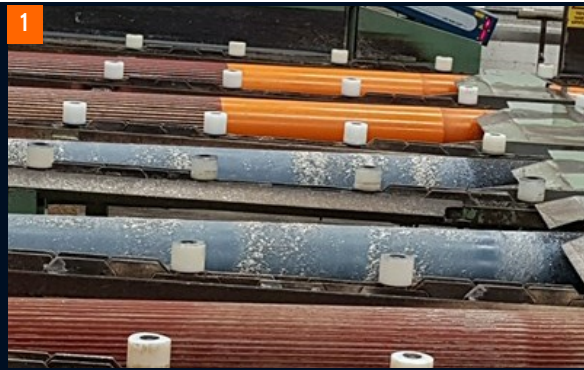
Worn lumber transfer rollers lack the required grip to transfer lumber quickly and efficiently. This inefficiency affected the ability of transferring lumber from one part of the plant to another, which was affecting revenue and production levels.

Grip Rollers in Lumber Mill were worn causing inefficient transfer of lumber system.

1. Rolls grip system worn smooth
2. Application of Belzona 1321 and Belzona 9211

The application was carried out in accordance with Belzona Know-How Leaflet SHM-12

Belzona 1321 (Ceramic S- Metal)  
Belzona 9211 (Supergrip Aggregate)
