# BELZONA 1812 IN USE AT PEAT POWER PLANT

ID: 8094

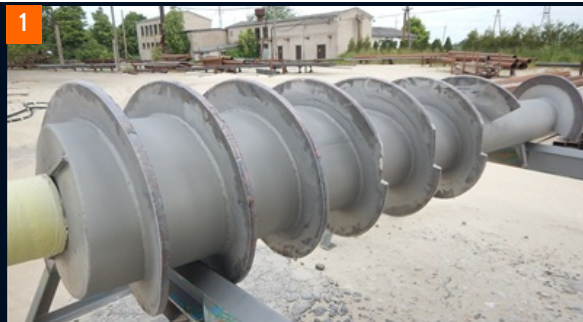
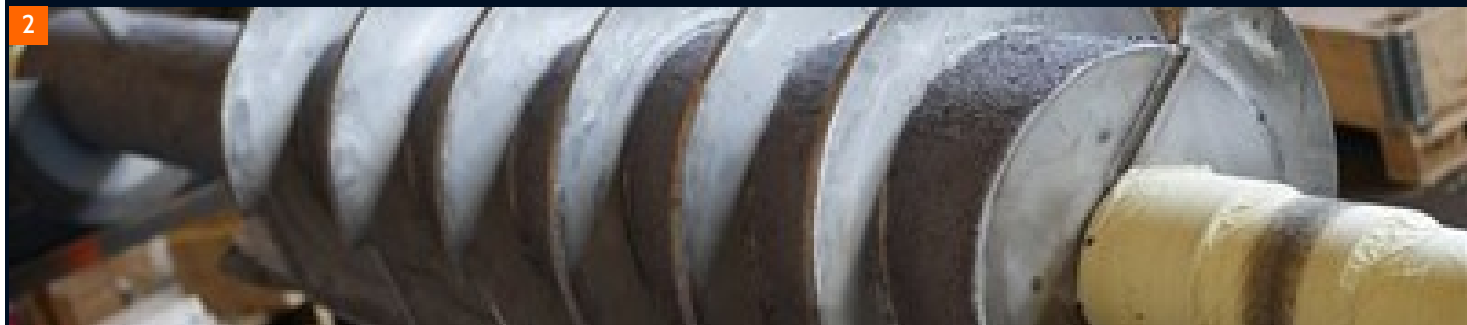
## PHOTOS

It is very time consuming and costly for the client. Welding would make the pipe fragile and very difficult to use post-process.

The customer's drawing shows that the screw tube must be welded with a hard facing CASTOLIN 5006. Screw was used for transporting peat.

1. Screw before Belzona coating
2. Screw complete with Belzona coating

Application was carried out in accordance with Belzona leaflet SHM-14. Grit blasting was used to prepare the surface, followed by a lining of Belzona 1812

Little down time for the customer and saving them money contributed to winning the job. According to the customer feedback, the screws have been working for a year and there is no sign of wear.
