# BELZONA SEALS RIVET TANK

ID: 8098

Sealing the base of a rivet tank to protect it against corrosion.

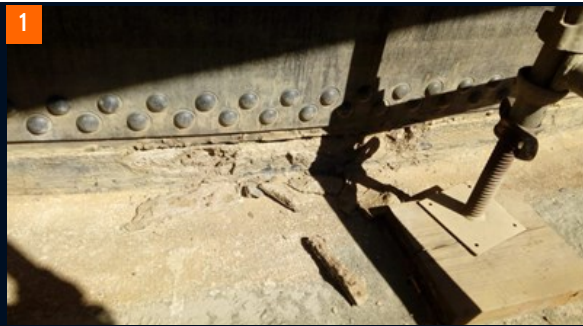
An existing coating had failed at the base of a rivet tank and degraded due to UV exposure. With the tank base unprotected moisture ingress was able to shoot underneath the tank as the tank expanded and contracted causing further corrosion.

1. Deteriorated base
2. Belzona 4111 chamfer angle
3. Belzona 5811 + 3111 first coat
4. Finished application
