# BELZONA PROTECTS HIGH TEMPERATURE OIL TANK

ID: 8099

Repair and protection of a glass fiber oil tank.

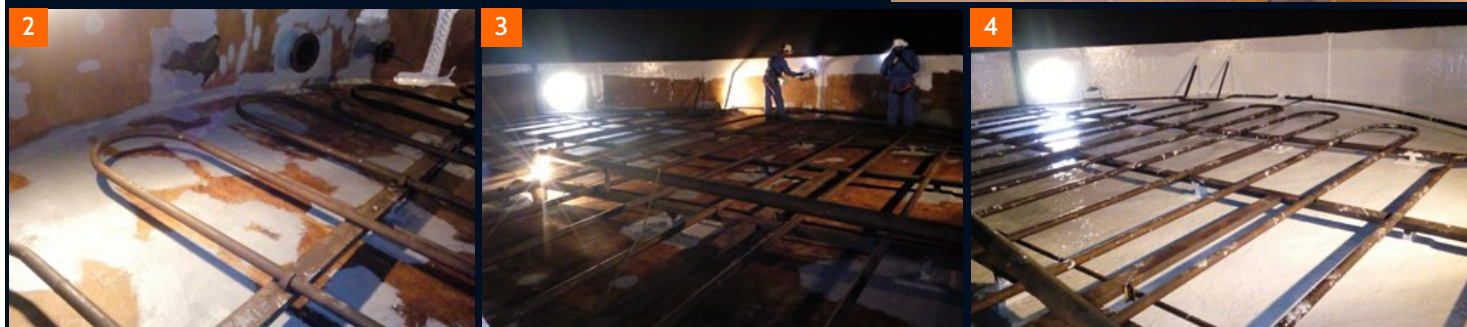
An oil tank operating at 70°C was corroding internally at the base of the tank due to the separation of water and hydrocarbons. The glass fiber tank was also starting to delaminate in areas underneath the heating pipes at the base of the tank.

1. Corrosion and delamination at the base of the tank
2. Belzona 1161 rebuilding
3. Belzona 5892 being applied
4. Finished application

This application was carried out in accordance with TCC-05. As this was a glass fiber tank some adhesion testing was carried out prior to the application being carried out. After good results were achieved from the adhesion testing the bottom of the tank and a meter up the internal walls were all blasted as this was where the corrosion was present. Belzona 1161 was used to rebuild areas where the fiber glass had delaminated under the heating pipes and also to reinforce supports beam at the bottom of the tank. A 2 coat system of Belzona 5892 was then applied to prevent future internal corrosion from occurring at the bottom of the tank.
