# BELZONA PROVIDES BONDING SOLUTION FOR TANK STAIRS

ID: 8100

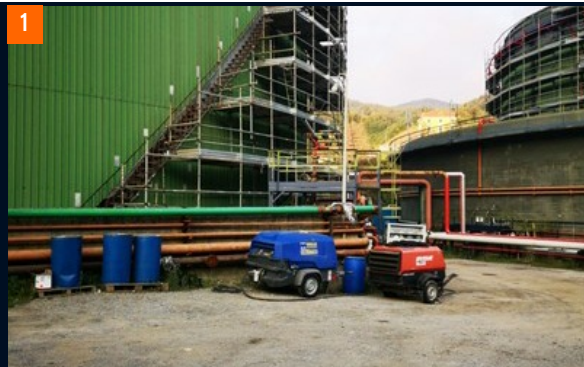
1. Overview of tank stairs
2. Severe galvanic corrosion
3. Belzona 1161 bonding the stairs to the tank
4. Finished application with a coating of Belzona 5811

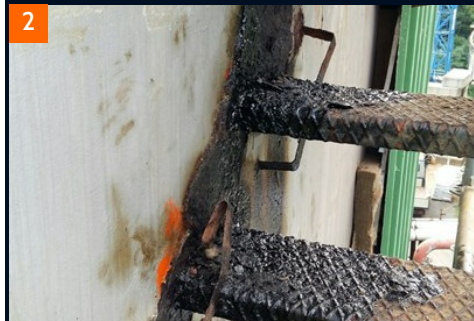
Stairs on the side of the tank suffering from severe galvanic corrosion, deeming the stairs unsafe to use.
