# BELZONA REJUVENATES STORAGE TANK

ID: 8102

Refurbishment of the internal base of a storage tank.

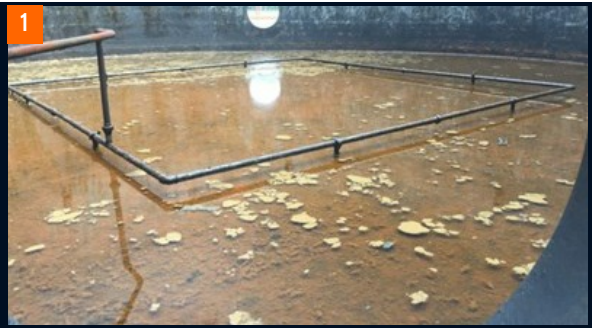
Due to a mixture of water and hydrocarbons, the bottom of the tank had started to corrode where the water sits. This is because the density of the water is greater than the hydrocarbons and as the steel is unprotected the tank corroded at the bottom.

1. Before application
2. Grit Blasted surface
3. Coating of Belzona 5811
4. Finished application
