# BELZONA 1321 TITANIUM PUMP REPAIR

ID: 8104

One of the largest refineries in Poland has significant damage to the titanium substrate of a KSB pump.

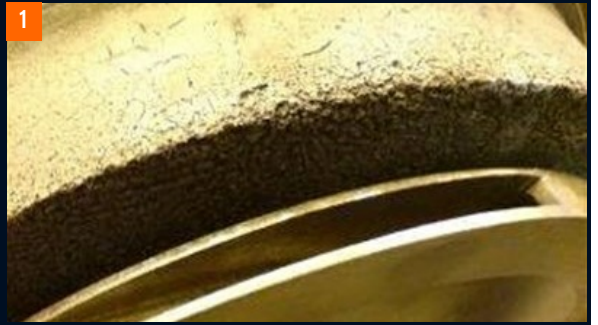
The KSB pumps were typically only lasting 3 months due to significant damage to the titanium substrate operating at a temperature of 60°C. The refinery contacted the local distributor for a Belzona solution to improve longevity of the pump.

Picture 1: Close up of damage to substrate.

The local distributor coated the pump with three layers of Belzona 1321 to extend the working life of the pump and protect the titanium substrate from further damage. The application was completed in accordance with Belzona System Leaflet CEP -01.

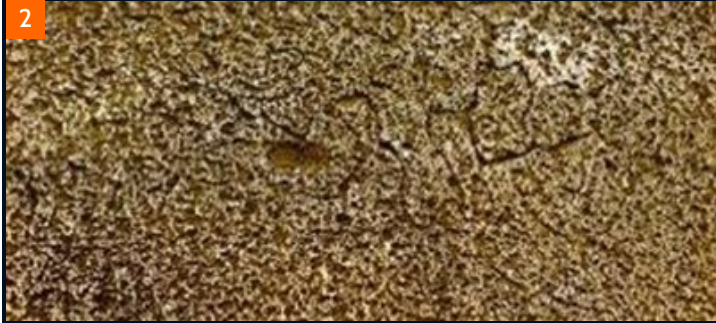
Picture 2: Close up of damage to substrate.

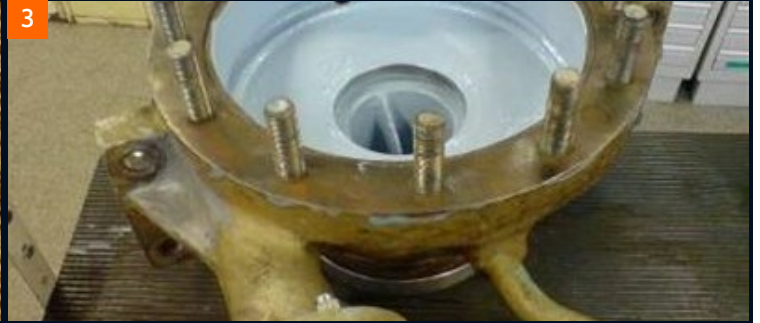
Picture 3: Completed Belzoan 1321 Coating.

Since applying the Belzona 1321 the pumps are now typically lasting 9 months saving the client money on down time and repairing more frequently.
