# BELZONA 4341 INTERNAL LINING PROTECTION AGAINST CHEMICAL ATTACK.

ID: 8105

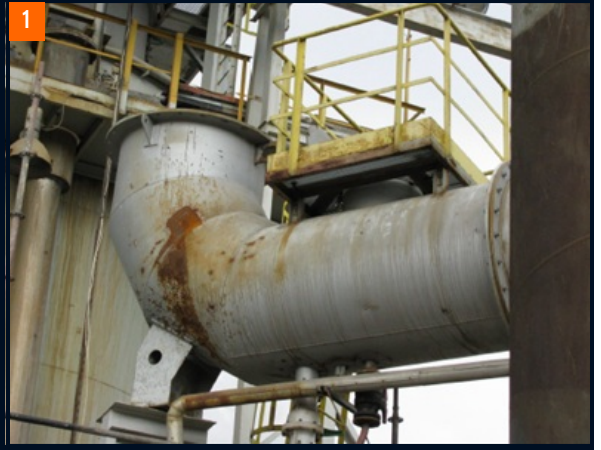
Chemical aggression condensation of hot burns caused the steel to corrode on the pipeline. Which led to perforation of the steel.

Picture 1: Visible wall perforation

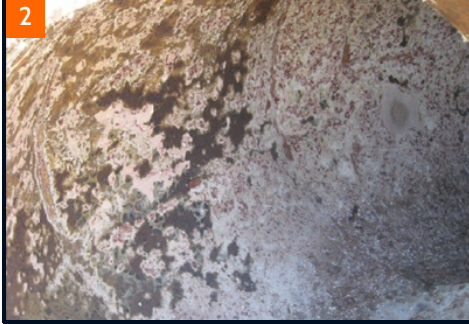
Phosphoric Plant Works discovered the plant equipment corroding at a fast rate, leading to perforation.

Picture 2: Internal surface corrosion

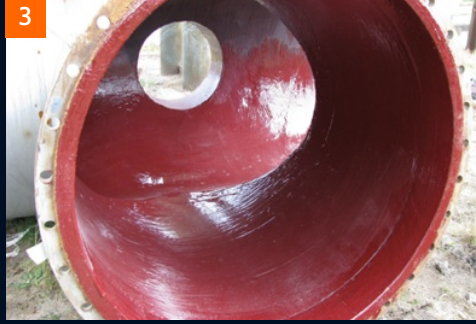
Picture 3: Belzona coating 4341

The application was carried out in accordance with Belzona Know-How Leaflet TCC-03

Belzona 4341 was a proven solution to protect the internal surface lining against chemical attack.

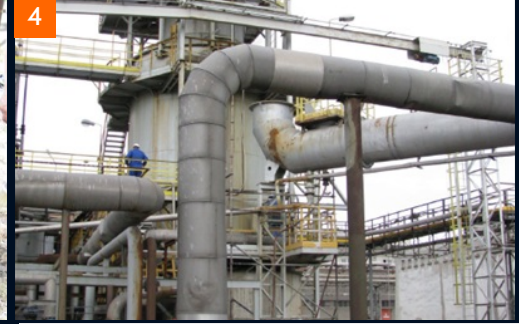
Picture 4: General view of the installation
