# BELZONA SEAL A TANK APPLICATION ON CRUDE STORAGE TANK AT A REFINERY

ID: 8108

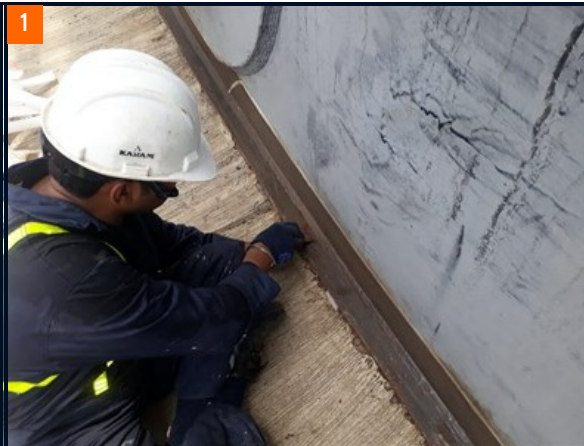
1. Surface preparation done on the shell and concrete base of the tank
2. Conditioner applied on the concrete base and the shell of the tank
3. Belzona 3111 along with Belzona 9311 was applied on the prepared surface of the tank
4. Final layer of Belzona 3111 has been applied and tape is ready for removal

Painting was removed from the shell upto a height of 0.2 meter from the base. The concrete was also cleaned and the surface was made clean dry and rough. Belzona 3911 (PSC) was applied on the concrete surface, Belzona 3921 (GSC) was applied on the cleaned metallic surface of the tank. Belzona 3111 was applied on the prepared surface. Belzona 9611 along with Belzona 3111 was applied. After the application gets cured, a final layer of Belzona 3111 was applied.
