# BELZONA REBUILDS LARGE MOTOR BEARING HOUSING

ID: 811

Electric motor bearing housing.

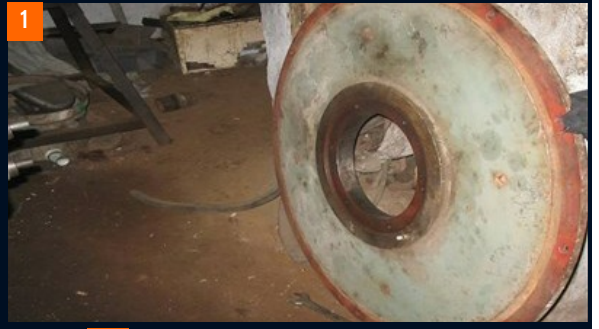
Bearing housing damaged due to mechanical failure.

1. General view of the worn bearing housing
2. Applying Belzona 1111 to rebuild the housing
3. Checking the dimensions after machining
4. Application completed
