# WATERPROOFING COVERED LABORATORY BUILDING WITH BELZONA SYSTEM 3111

Flat cover of the main laboratory building within the thermal centre of As Pontes-Galicia

Coal Thermal Center in AS Pontes-Galicia

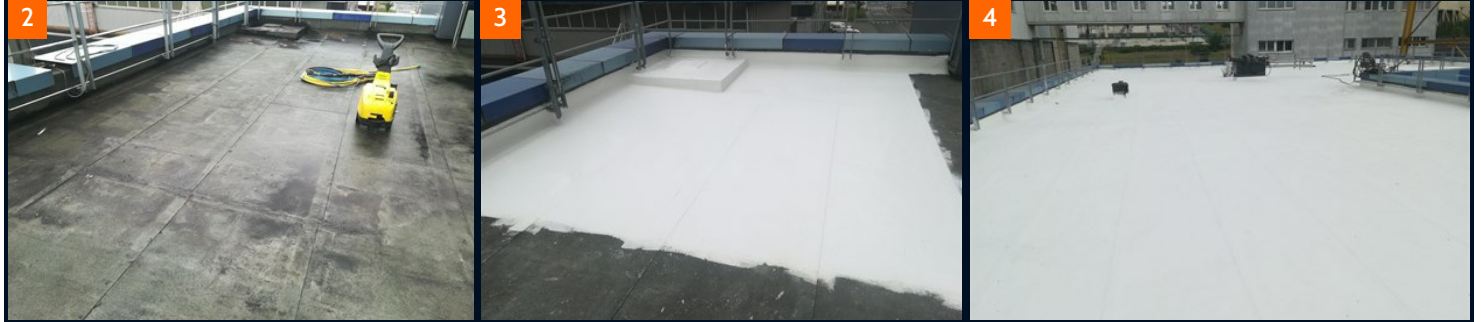
1 - START STATUS

2 - CLEANING

3 - APPLICATION BELZONA 3111

4 - FINAL STATE WITH SECOND LAYER OF BELZONA 3111

The asphalt roof 600 m2 was repaired with Belzona 3111 after repairing with Belzona 2211.
