# BELZONA PNEUMATIC RUBBER FENDER REPAIR

ID: 8115

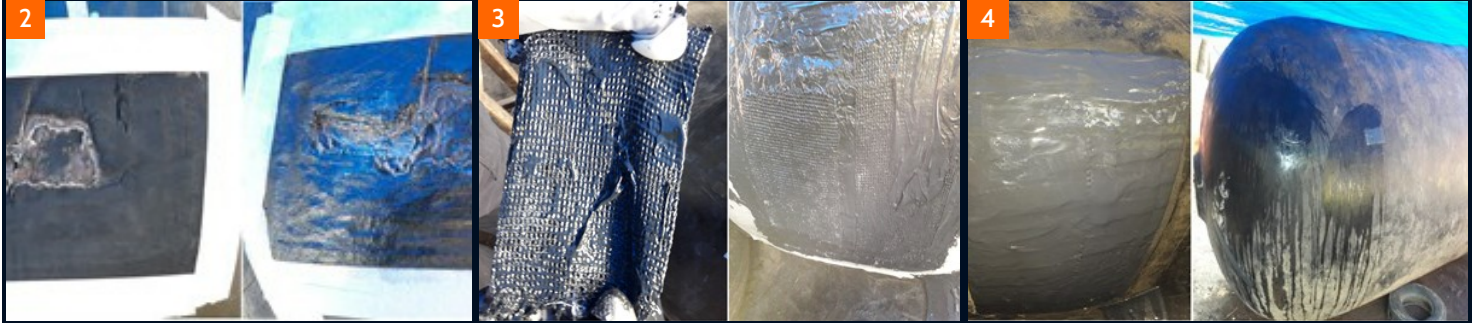
Fenders were wrapped with tyres & chains for additional protection, which damages the fender & it become worn & punctured. Hence they were in need of a full service or replacement.

The Aban offshore company sent a fender which was being used to protect rig platform legs & they had become worn and punctured over time.

1. Deflated Fender & Punctured Area
2. Surface Prepared & Conditioning
3. Application With 2211 & 9341
4. Finished Application

Application was carried out in accordance with Belzona Know-How System Leaflet SOS-12. Surfaces were prepared using a MBX machine. After Conditioning the areas with 2921 were rebuilt with Belzona 2211 incorporating Belzona 9341 (Reinforcement Tape).
