# BELZONA RESURFACES DETERIORATED BIKE RACK AT UK COLLEGE FACILITY

ID: 8124

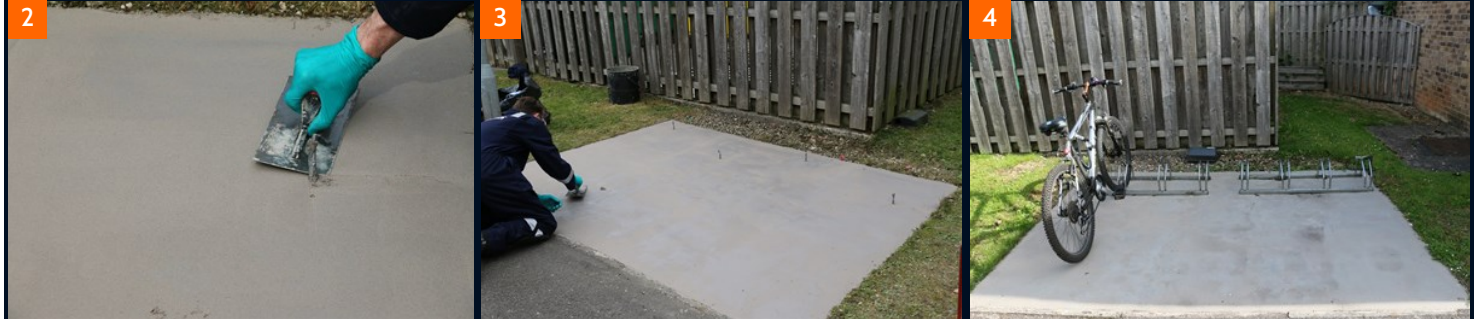
The bike rack at a UK college facility was showing significant signs of deterioration, with vast areas of the concrete surface spalled or cracked due to wear and weathering.

1. Bike rack showing large areas of spalled and deteriorated concrete
2. Application of Belzona 4131 (Magma Screed)
3. Resurfacing the final area of the bike rack
4. Revisited several weeks later and in perfect condition

The metal rack, which was bolted in the concrete, was removed and the surface was inspected for areas of crumbling and loose material. Any loose concrete was chiselled away, ensuring a solid surface. Next, the entire bike rack was pressure washed, removing any contaminants and plant growth. Once dry, Belzona 4911 was used to condition the concrete prior to the application of Belzona 4131. Working across in sections, the bike rack was resurfaced using a float to provide a smooth finish.
