# BELZONA UPGRADES SAFETY GRIP SYSTEM AT UK COLLEGE FACILITY

ID: 8125

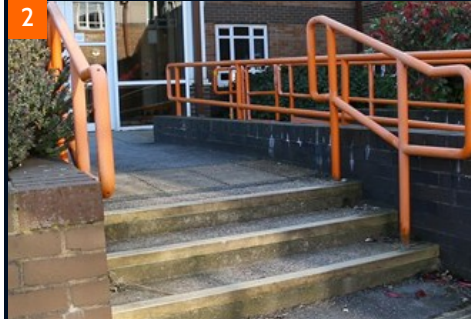
1. The old grip system had become redundant and was actually facilitating further damage to the concrete steps
2. Altogether, three sets of steps required a new grip system
3. Application of the Belzona grip system
4. Finished application

First, the existing grip system was removed from the concrete steps and preparation began to ensure a firm and clean substrate. Due to water ingress underneath the metal plates, there was some spalling concrete around the anchor points. Belzona 4141 was used to reform these areas and provide a neat edge on to which the new grip system could be applied. The Belzona 4411 and Belzona 9211 units were mixed then together and applied on to the concrete step nosings in strips.
