# BELZONA ELASTOMER USED TO REPAIR TORN CONVEYOR BELTS AT RECYCLING PLANT

ID: 8126

Recycling Plant - Zurich, Switzerland

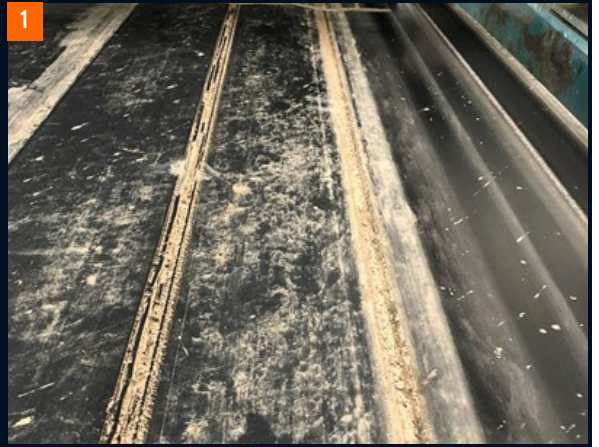
A recycling plant specialising in urban mining, extracting and reusing building materials from previous sites e.g. concrete. At the facility, a large conveyor belt had become caught on a defective scraper, causing a linear tear over 32m along the rubber.

1. Damage along the length of the conveyor belt
2. Heavy scoring and tears resulted in shutdown
3. The repair area masked off for application of Belzona 2311
4. The Belzona repair allowed for a return to service the very next day

The application was carried out in accordance with Belzona Know-How System Leaflet SHM-1. Any loose parts of the rubber were first cut away, before the substrate was prepared using a rotary wire brush. The entire area was subsequently cleaned using Belzona 9111. The defected areas were masked off and conditioned, before Belzona 2311 was applied to the surface. This is a fast-curing material that is cold-curing and requires no specialist application tools. To reinforce the repair Belzona 9341 (a flexible and strong fabric mesh) was embedded into the elastomer and then encapsulated with a secondary application of Belzona 2311.

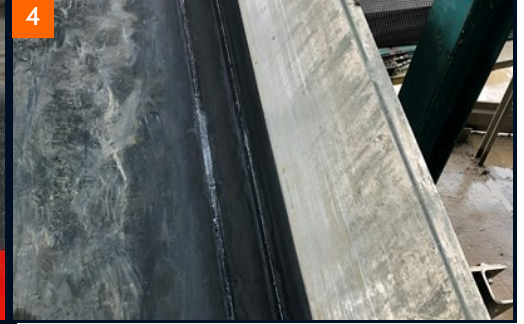
Due to the fast turnaround required, the Distributor carried out the repairs on the same day. The application took 7 hours to complete compared to replacement, which would have caused approximately 3 times the amount of downtime. This allowed the plant to run the conveyor belt the very next day. This belt is still in use after 9 months without any problems at the repair points.
