# SHOPPING CENTRE STEP WITH BELZONA GRIP SYSTEM

ID: 8128

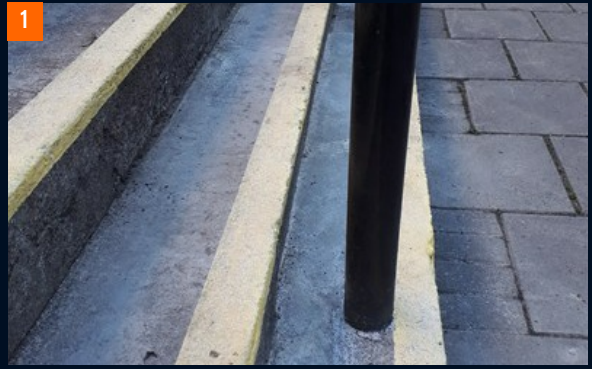
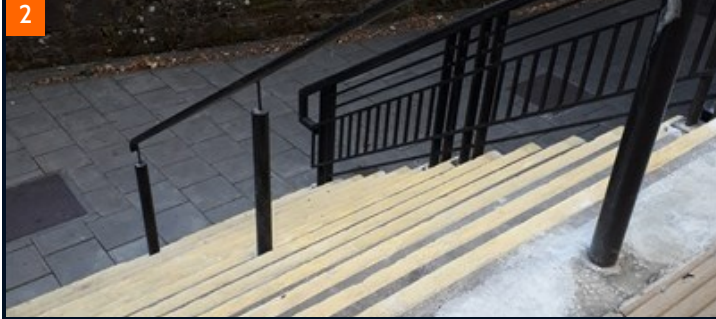
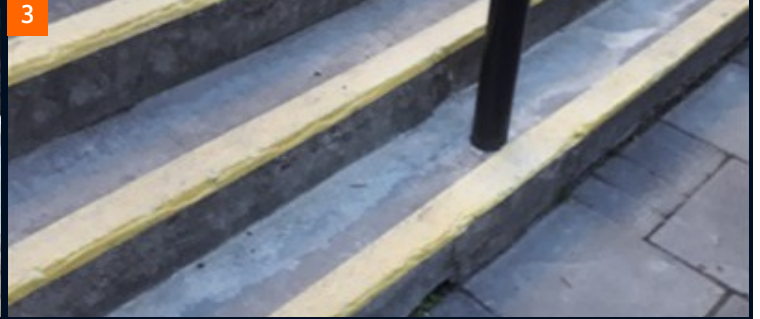
A set of stone steps leading to the entrance of a shopping centre was identified as a potential slip hazard in wet or icy conditions. A hard wearing, easy to see grip system was required to give positive traction to pedestrians using the steps.

1. Close up of application
2. Top down view
3. Bottom view

The step nosings were abraded with a floor grinder. The Belzona 4411 system was then applied by brush before the Belzona 9221 was sprinkled on top to form the grip system
