# POTATO AND STARCH PUMPS REPAIRED WITH BELZONA

ID: 813

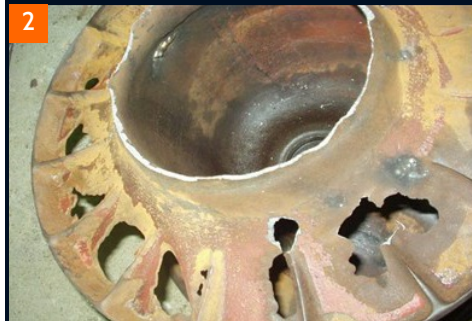
1. General view of one pump
2. The badly damaged impeller
3. Rebuilding the impeller
4. Two pumps rebuilt and coated

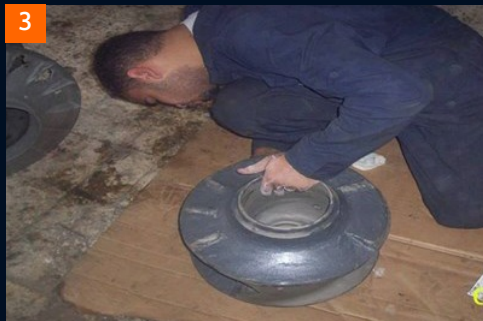
Corrosion of the casings and impellers caused over long service life and through erosion. The impellers were badly eroded with thin edges and many holes.

Belzona 1311 (Ceramic R-Metal)  
Belzona 1341N (Supermetalgilde)
