# BELZONA PROVIDES UNCONVENTIONAL TANK BASE SEALING

ID: 8131

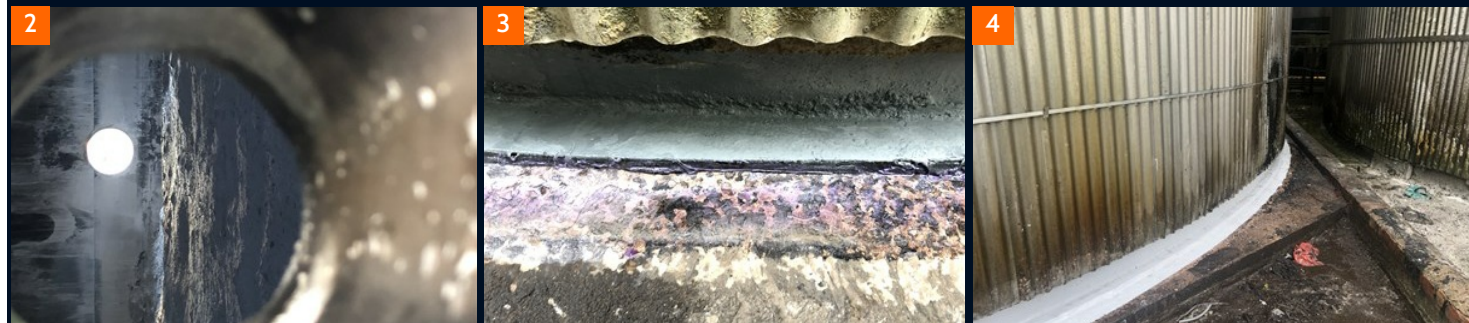
The problem was leakage of product under the base plate in trickles suggesting there is a pinhole in the steel annular plate. It was nearly impossible to remove the hardened product and consequently the location of the pinhole is impossible to locate.

1. Showing annular plate / concrete plinth leakage and corrosion
2. Shows solidified product in the base of the tank
3. Application of conditioners
4. Completed application

The steel annular plate was abraded manually to give a rough finish, and the concrete receive the same treatment to remove any debris and contamination. Belzona 2911 was applied between the base plate and plinth and allowed to dry. Belzona 2211 was applied into the gap to provide a seal and prevent further product leakage. Belzona 3921 and Belzona 3931 were applied to condition the annular plate, followed by two coats of Belzona 3131 to finish. The application was completed in accordance with Belzona System Leaflet GSS-3.
