# BELZONA UPGRADES SPIRITS CONTAINMENT AREA

ID: 8133

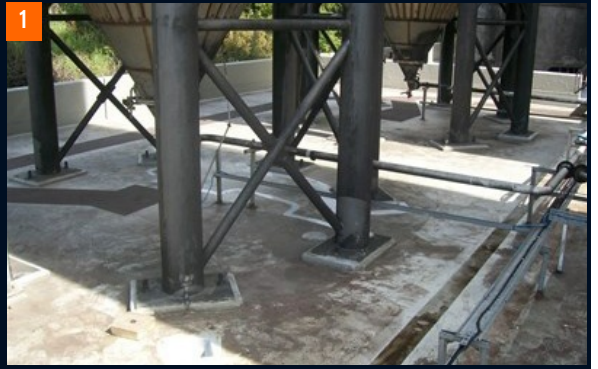
The existing protective system had failed. The chemical containment area could no longer be relied upon to prevent liquid loss into the groundwater/watercourse in the event of a spillage.

Spirit containment area/bund became damaged over time.

1. Containment area prior to Belzona Application
2. Application of Belzona 5811 underway
3. Completed Application
4. Area revisited in 2019

Application was carried out in accordance with Belzona Know-How System Leaflet TCC-15. Belzona 4131 and Belzona 4141 were used to repair the degraded sections of the walls and to create fillets to all horizontal and vertical corners of the bund. The floor was screeded with Belzona 4131 at 6mm to provide maximum impact resistance. A two coat system of Belzona 5811 was then applied to all the internal surfaces of the bund.

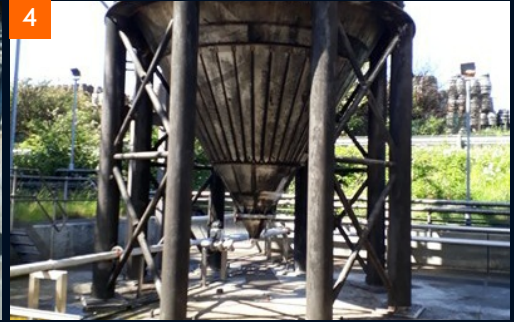
The Belzona system provides excellent resistance to permeation. The reinforcement of wall and floor joints will ensure long term containment without cracking or breaks in the bund lining. The coating is a bit dirty (covered in whisky black fungus) but otherwise in perfect condition 8 years on!
