# BELZONA KNOWS HOW TO REBUILD A DIAPHRAGM PUMP

ID: 8135

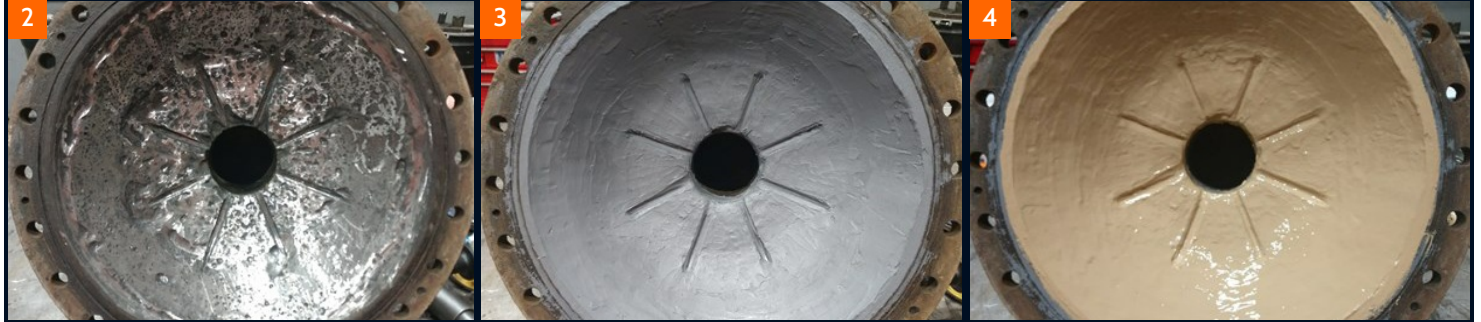
This 30" diaphragm pump was not performing as it should, so Belzona was asked to rebuild it. The pump was originally installed in the 1960's and has been operating pretty much full time since. Once opened, the cause of the lack of performance was revealed as there was quite a bit of erosion and metal loss.

1. The pump opened.
2. The pump cleaned.
3. The pump rebuilt with Belzona 1111.
4. The pump coated with Belzona 5831

Due to the location and timing, we were only able to do hand tool prep. The customer was made aware that the proper method would be to grit blast. Every effort was made to remove all contaminants and corrosion using a needle gun to clean, and a grinder to roughen the surface. 2 kg of Belzona 1111 Super Metal was mixed in several batches and applied to fill the pitting and wear, and to rebuild the edge. Most areas were up to 3/4" deep, and the outer edge averaged 3/4" deep by 1.5" wide in metal loss. 2 coats of Belzona 5831 ST Barrier was then applied by hand and allowed to cure.
