# ENHANCING PUMP EFFICIENCY WITH BELZONA

ID: 814

The efficiency of the pump had decreased due to the eroded casing and impeller.

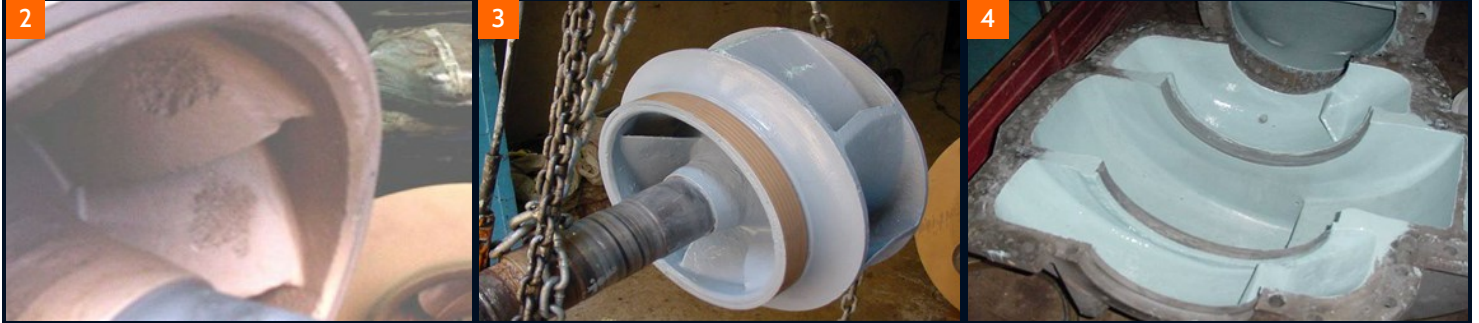
1. Pump removed from service
2. Cavitated impeller
3. Impeller rebuilt and coated
4. Casing completed

The pump casing and impeller were rebuilt to their original dimensions. As a result and with coating the casing and impeller with Belzona® 1341 the efficiency of the pump has been increased from 800 lit/sec. to 1100 lit/sec.
