# BELZONA SEALS SILO FLANGE

ID: 8141

Power Plant, Liverpool, UK

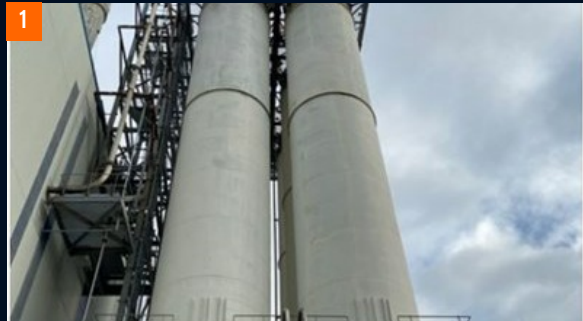
Dry powder silo had mastic sealant between flange joints which hardened and shrunk. This resulted in the mastic falling out leaving exposed gaps. The silo is tall and difficult to reach so using a specialist rope access contractor was the best option.

1. Silo showing the suspect flange joint
2. Leaking flange joint
3. Rope access contractor applying Belzona materials
4. Completed application on powder silo
