# HIGH SPEED FERRY PROPELLER CAVITATION DAMAGE REPAIR

ID: 8145

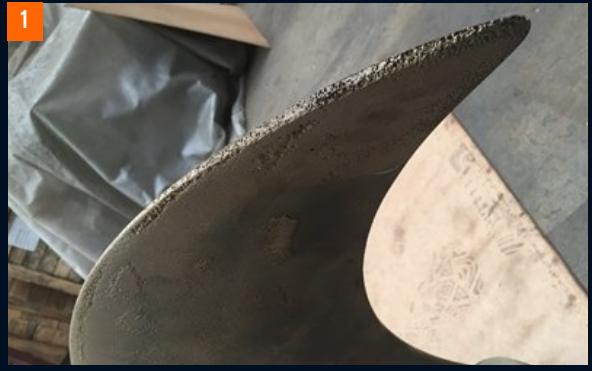
Cavitation damage on both propellers of high speed ferry. The damage is more intense on the blade leading edges. The damaged propellers causing ferry two operate with some vibration and less hydrodynamic efficiency.

1. Cavitation damage on the propeller.
2. After surface preparation.
3. Application Belzona 1311 (Ceramic R-Metal).
4. The surface faired after Belzona application.

Application was carried out in accordance with Belzona Know-How System Leaflet SOS-01. Propeller surface blasted in blasting cabin. Surface was cleaned with Belzona 9111 (Cleaner & Degreaser) after blasting. Immediately following surface preparation Belzona 1311 (Ceramic R-Metal) is applied on the surface. After the product is cured, the surface was grinded and faired to achieve smooth surface.
