# 90 YEAR OLD CAST IRON LAKE DISCHARGE SYSTEM

ID: 8146

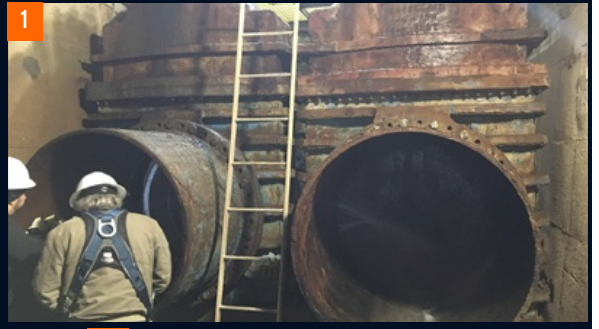
There was no way to replace the old bonnets, valves and pipe without bringing in a crane to take the old bonnets up 100ft to the top. The customer would have had to build a special way to bring them through the vertical tunnel without damaging the 90yr old concrete which could have weakened the structure. Customer needed a solution to keep the existing valves, bonnets and pipes in place for several years to come. The age of the cast iron and the environment had created heavy corrosion in the area.

1. Bonnets, valve bodies and pipe prior to Blasting
2. Bonnets prior to blasting
3. Bonnets coated
4. Valve bodies and pipe coated.

Application was carried out by abrasive blasting the cast iron to SSPC SP10, whilst keeping a heater running in the area to keep the temperatures in the mid 60's f (>15c), raising the temp of the material to between 68-70F (20c to 21c) for the Belzona 5811. The first coat was applied, a second coat was applied within 24hrs to ensure proper coverage on the valve bodies. On the bonnets and pipe, Belzona 5831ST was applied whilst controlling the running water in the pipe with a makeshift dam. On the bonnets that were sweating, the surface was grit blasted and dried before applying Belzona 5831ST immediately.
