# RENOVATION OF A LIQUID CYCLONE HEAD WITH BELZONA

ID: 8148

Inside of a liquid cyclone head for paper

Paper mill in France

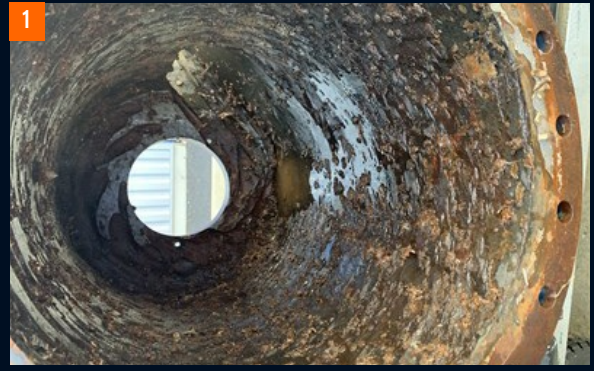
The piece of equipment was badly damaged by erosion caused by the paper paste which is very abrasive.

1. Liquid cyclone head badly damaged
2. After grit blasting
3. After Belzona 1814 application
4. Completely renovated after Belzona 1321 application

Application was carried out in accordance with Belzona System Leaflet VPF-01 and VPF-02. The corroded metal structure was blasted back to bare metal using grit blasting and the eroded areas were rebuilt applying Belzona 1814 with spatula. Belzona 1321 was applied with brush to protect against future erosion/corrosion.
