# BELZONA 4111 STANDS UP TO HEAVY MINE TRAFFIC

ID: 8149

Mine site wash bay with a concrete floor.

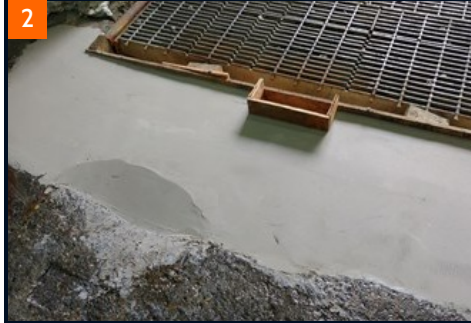
Extremely deep wear in the concrete floor in the tread areas of this wash bay. Full mine haul trucks roll across this floor year round with cleated tire chains. The deep ruts were being covered with heavy steel plates. Both the ruts and steel plates were causing a hazard to the crew when walking in the area.

1. Original wear and one of the the mining trucks causing the damage
2. Belzona 4111 applied May 2016
3. Belzona 4111 in April 2017
4. Belzona 4111 in November 2019

A grinder and wire wheel was used to remove all the loose material from the surface of the area of application. The exposed steel re-bar was prepped with the grinder to remove all rust and corrosion. Belzona 4911 conditioner was then mixed and applied over the area, and immediately following the Belzona 4111 was mixed and applied and finished with a steel trowel. Note that plywood was used as a form. In this situation, aesthetics was not a concern, so no release agent was used. When the ply wood was removed, some of the wood fibers remained stuck to the Belzona 4111, but did not have any impact on the application.
