# BUTTERFLY VALVE REFURBISHED WITH BELZONA

ID: 815

Butterfly valve in water distribution system.

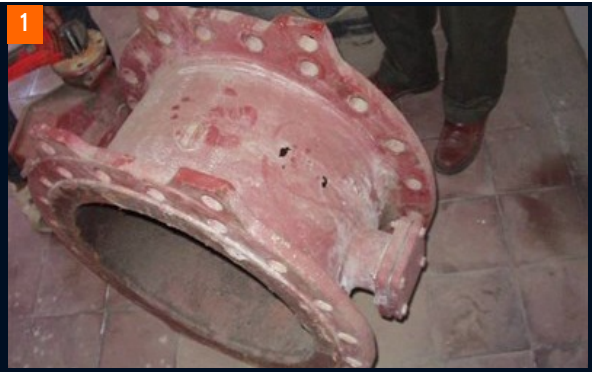
Body badly corroded and holed in places. In addition rubber seal on valve disc completely deteriorated.

1. General view of the valve
2. The worn out rubber seal
3. Rubber seal was perfectly cast
4. Valve rebuilt and coated, application complete

Belzona performed complete repair and protection to the valve body, disc and rubber seals.
