# BELZONA 5721 LEP SOLUTION FOR COLD WEATHER

ID: 8150

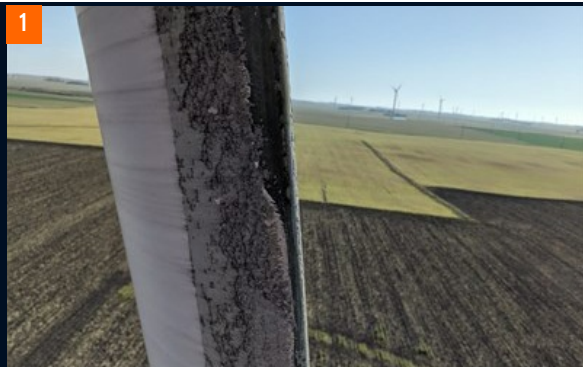
Over time, the leading edge of wind turbine blades become eroded and lose efficiency and power production for the turbine generator. Because of the time of year, the weather was very cold, and a blade repair solution was needed to properly complete the repairs.

1. Damaged leading edge of wind blade
2. Belzona 5721 ready to mix
3. Finished Belzona 5721 application on leading edge
4. View of the Wind Farm

The application was carried out in accordance with a modified version of Belzona Know-How System Leaflet FBC-1. The blades were coated on the turbine at the operation site. The pitting and loss of surface on the leading edge was resurfaced with a filler product and rebuilt to dimensions. The surface area was sanded down with a mechanical sander and cleaned with a rag and non-residual solvent cleaner. One coat of Belzona 5721 at 20 mils (508µm) was applied.
