# FERRY PIPE LEAK REPAIRED BY BELZONA

ID: 8152

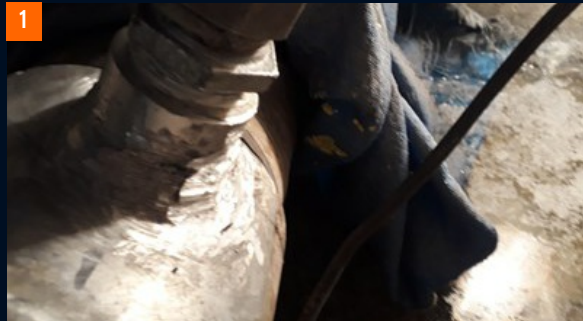
A leak was found on a pipe section during docking. A temporary repair was required to stop this leak before long term repairs could be carried out.

1. Leaking area
2. Area roughened with grinder
3. Belzona 1161 applied
