# BELZONA PROTECTS TANK ROOF AGAINST SULPHUR FUMES

ID: 8154

Repair of a Sulphur tank roof.

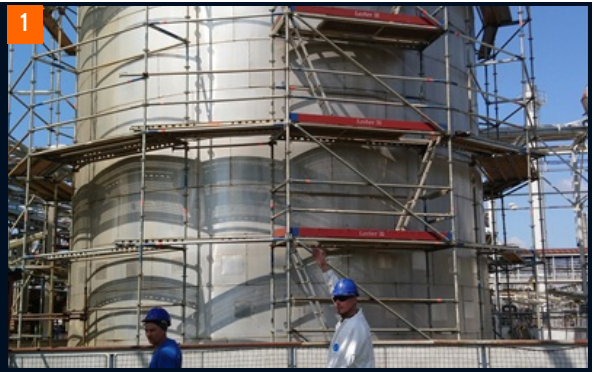
- 1.) Outside view of the Sulphur tank
- 2.) Corroded tank roof
- 3.) 2 coat system of Belzona 1593 applied to the roof
- 4.) View of the tank roof from the bottom

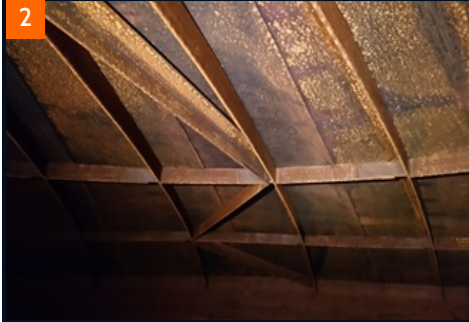
A build-up of condensation from the 100% liquid Sulphur had caused the tank roof to pit and corrode.

This application was carried out in accordance with Belzona system leaflet TCC-05. The tank roof was cleaned and then grit blasted to SA 2.5, achieving a 75 micron profile to provide an excellent level of adhesion to the substrate. Once grit blasted, any pits were filled in with Belzona 1511 before 2 coats of Belzona 1593 were applied to the tank roof.
