# REPAIR OF SEA WATER INLET VALVE WITH BELZONA

ID: 8157

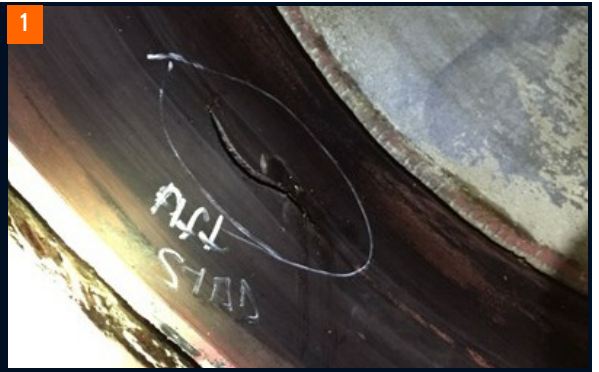
Sea water inlet valve sealing rubber surface has been damaged. Valve is not sealing properly.

1. Damaged surface of the valve.
2. After surface preparation.
3. Application of Belzona 2911.
4. Application of Belzona 2211.

Application was carried out in accordance with Belzona Know-How System Leaflet VPF-03. Damaged rubber surface was undercut and abraded to achieve a mechanical bond. The surface was conditioned with Belzona 2911 and allowed the cure. Then Belzona 2211 was applied and allowed to cure.
