# BELZONA PRODUCTS REPAIR AND WATERPROOF WIND TURBINE BASE

ID: 8158

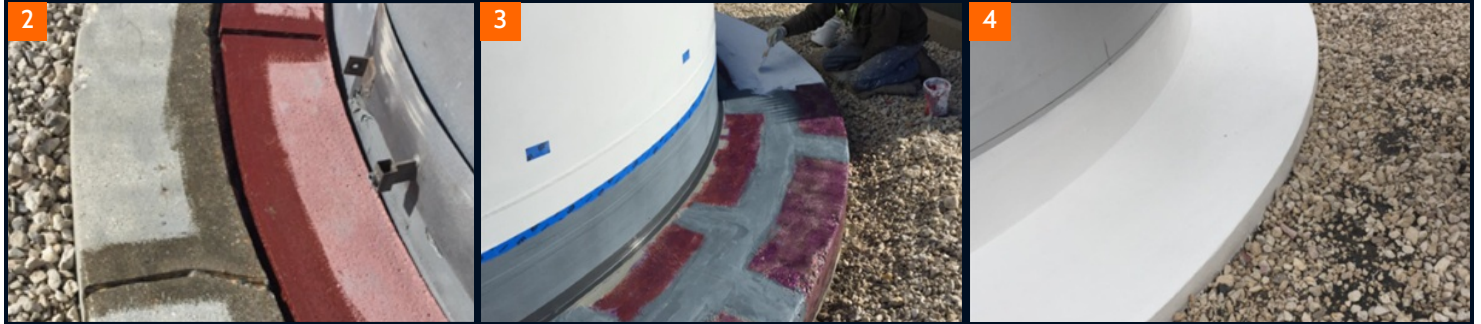
## PHOTOS

1. Damaged concrete base with coating peeling.
2. Damaged concrete base showing old grout not bonded to the old concrete.
3. 4131/4911 bonding the old concrete and old grout forming a new circular base. The 4511 expansion joint product applied in the interface. 3111 being applied around the finished base.
4. The whole base up to the metal structured completely waterproofed with 3111.

Took all loose concrete and old loose grout out. The perimeter area of the tower was grouted with Belzona 4131. Belzona 4131 was used to make a new circular base around the interface. Belzona 4511 was then used in the interface area as the expansion joint sealant between the concrete and the metal. Finally the whole tower base was waterproofed up to the metal with Belzona 3111.
