# BELZONA PROTECTS TANK LEGS FROM CORROSION

ID: 8159

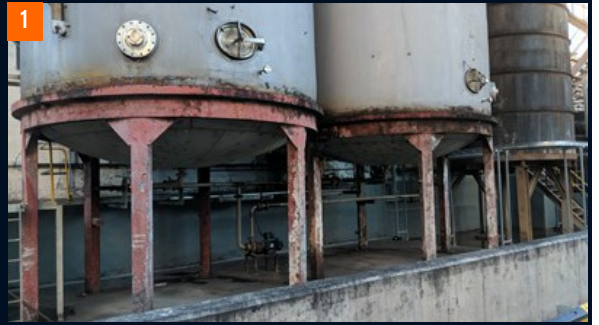
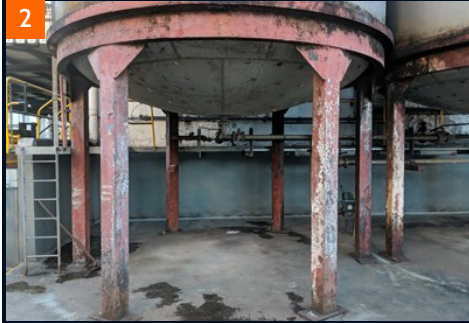
Several tank legs were experiencing corrosion. Around distillation sites a specific fungus that feeds from ethanol grows. This fungus creates a rough surface that traps water against a surface. This particular distillery is close to the sea, meaning much of this water would have salt within it. The combination of these two factors gives great potential for the corrosion of any unprotected metal.

1. Legs before
2. Legs before
3. 1st coat of Belzona 5811
4. 2nd coat of Belzona 5811

Blasted to SA2.5 & 75 microns using Sat blast system Two coats of Belzona 5811 then applied in accordance with Belzona System Leaflet TCC-06.
