# MEDIA FILTERS PROTECTED WITH BELZONA

ID: 816

## PROBLEM

Filters were suffering internal corrosion and required protection to prevent further loss of wall thickness.

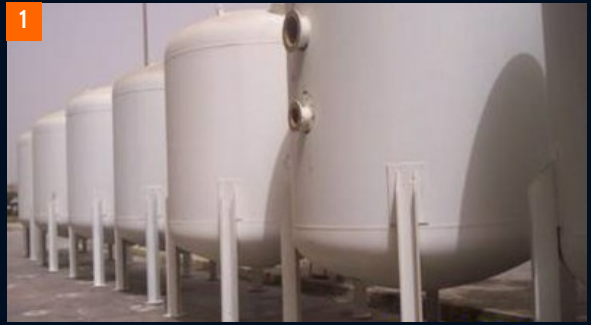
1. General view of the filters
2. Surface before preparation
3. Filter internals after coating
4. Covers were also protected
