# BELZONA PROTECTS NEW SEA WATER PUMPS

ID: 8165

New pumps requiring internal protection prior to going into service

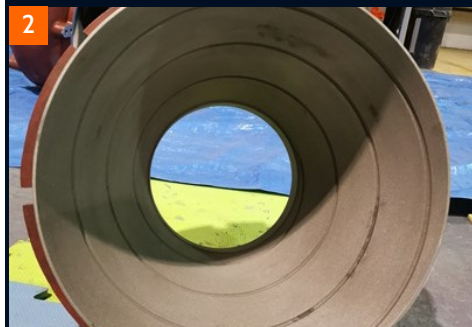
1. New pump components delivered for protection
2. Pieces grit blasted
3. Completed application of one of the pieces
4. Completed application

The application was undertaken in accordance with CEP-01. The pumps were delivered to the Belzona workshop in Wrexham where the team grit blasted the components to SA 2 ½ with a minimal profile of 75 microns. Each of the internal areas were then coated with two coats of Belzona 1341 and allowed to cure prior to returning to the client.
