# BELZONA APPLY INTERNAL LINING TO HEAT EXCHANGER SHELL

ID: 8166

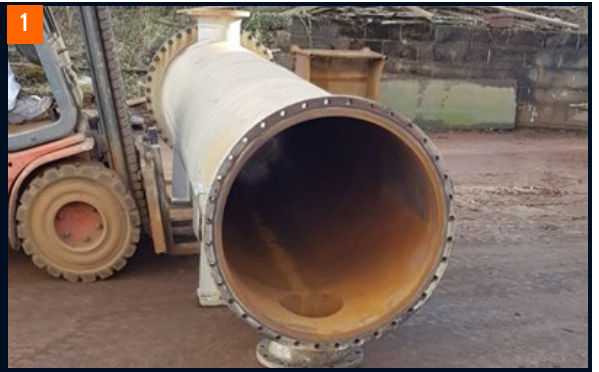
1. Equipment delivered to Belzona Technosol workshop
2. Extent of the damage
3. First coat of Belzona 1593
4. Second coat Belzona 1593

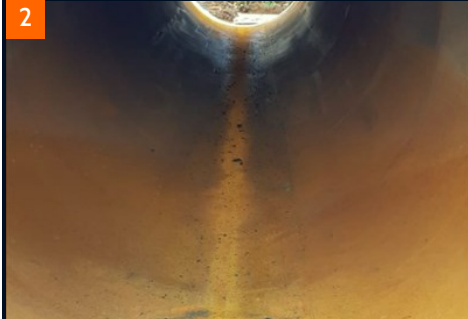
Internal corrosion to the internals of a heat exchanger

The heat exchanger was dismantled and delivered to the Belzona workshop in to two parts - the main shell and the dome end. The internal substrate was grit blasted in our workshop under controlled conditions. The pitted steel within the shell was then repaired using Belzona 1511. Following this two Belzona 1511 Nozzle Inserts were bonded into both drain and vent nozzles on the cap end, guaranteeing total encapsulation within these areas. Following the repair, two coats of Belzona 1593 were applied to provide long-term protection. Completed in accordance with Belzona System Leaflet HEX-03
