# BELZONA RENOVATE A PROCESS TANK

ID: 8169

Internal lining of a wheat starch milk tank in a factory

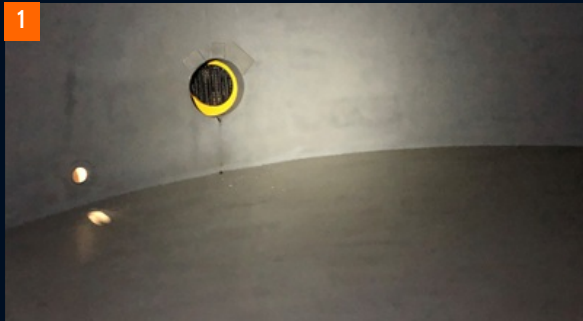
The internal lining of the tank was corroded due to the products being acidic when they are at high temperatures.

1 - Tank after grit blasting 2 - During application of Belzona 5892 3 - Tank after complete coating

Application was carried out in accordance with Belzona System Leaflet TCC-5. The tank was previously grit blasted to remove the rust before applying 2 coats of Belzona 5892. Small retouches were made before the coating system was post-cured with steam.
