# BELZONA COATS 2 X PEMO PUMPS

ID: 8178

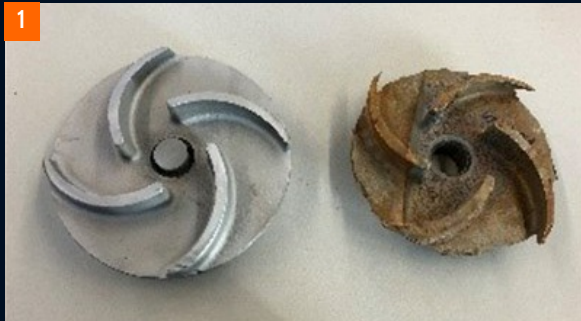
2

1. Pemo pumps in the service center. Additional blasting work to better inspect the pumps. Image
2. After blasting, a mold was made for the re-profiling of the impellers with Belzona 1111. Additional construction of the housing passage with Belzona 1111.
3. After re-profiling, the parts were turned to size on the lathe.
4. In addition, the parts were coated with Belzona 1321 Grey and Belzona 1341 Blue.

All components of the Pemo Pumps were previously grit blasted according to SA 2½ / 75µ. After grit blasting, the components were immediately re profiled with Belzona 1111 and Belzona 9341. This process was repeated several times to achieve the original size. After re-profiling, the parts were turned to the original size on the lathe. After the re-profiling was completed, the pumps would be coated with Belzona 1321 Grey and Belzona 1341 Blue. Application was carried out in accordance with Belzona Know-How system leaflet CEP-3
