# BELZONA SAVES FISHING BOAT TAILSHAFT

ID: 818

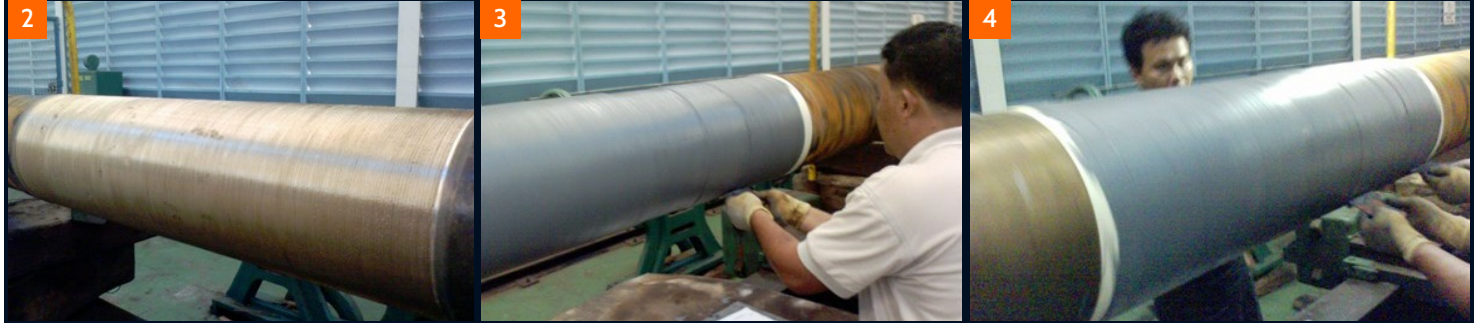
## PHOTOS

Severely worn bushing on the propeller shaft damaged the cutlass bearing causing vibration on the fishing vessel.

1. Worn bronze bushing
2. Surface preparation using machining technique
3. Application of Belzona 1111
4. Application of Belzona 1111 being completed

Repair was carried out in accordance with Belzona Know-How System Leaflet MPT-1

Belzona 1111 (Super Metal)
