# BELZONA REPAIR STRAINERS

ID: 8180

Fishing vessel strainers

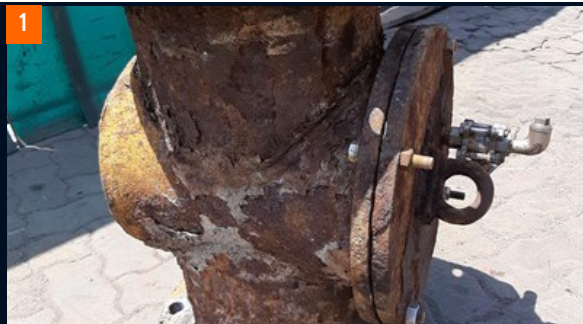
Strainers badly eroded

1. Strainer badly corroded
2. Strainer Flange
3. After grid blast
4. Final product done with Belzona 1111 and Belzona 1321, with Belzona 5811 on the outside.
