# BELZONA REPAIR ON A THRUSTER BODY

ID: 8182

Thruster body repair.

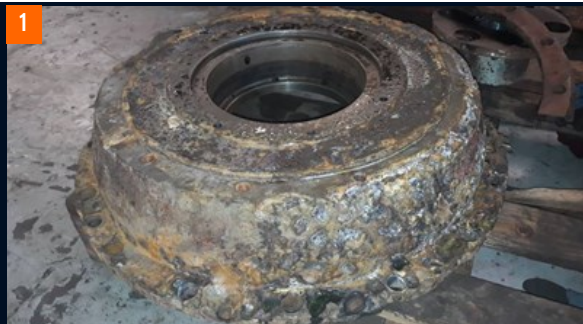
Heavy wear on body of thruster due to sea water.

1. Before 2. after repair with Belzona 1111 and Belzona 1321.
