# ACID MIXING TANK DRIP MITIGATED WITH BELZONA

ID: 8183

Repair and protection of a concrete containment area in a brewery.

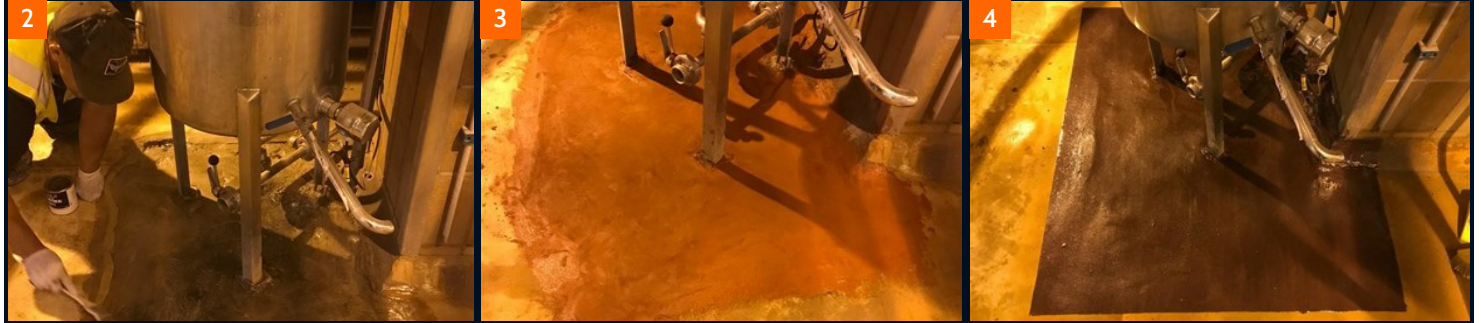
Regular dripping from the acid mixing tank was causing severe degradation to the concrete at the feet of the tank. The acid mixture had been absorbed into the concrete, threatening to damage the supporting structure.

1. Original condition of damaged concrete 2. Post cleaning, surface primer being applied 3. Concrete rebuilding 4. Complete application

The application was carried out in accordance with Belzona System Leaflet FPA-3. The concrete was washed repeatedly with Belzona 9111 (Cleaner Degreaser) to remove acid contamination from the concrete. The concrete surface was rebuilt using Belzona 4131 (Magma-Screed) and protected from further chemical attack with Belzona 4311 (Magma CR1).
