# BELZONA REPAIRS A THRUSTER

ID: 8184

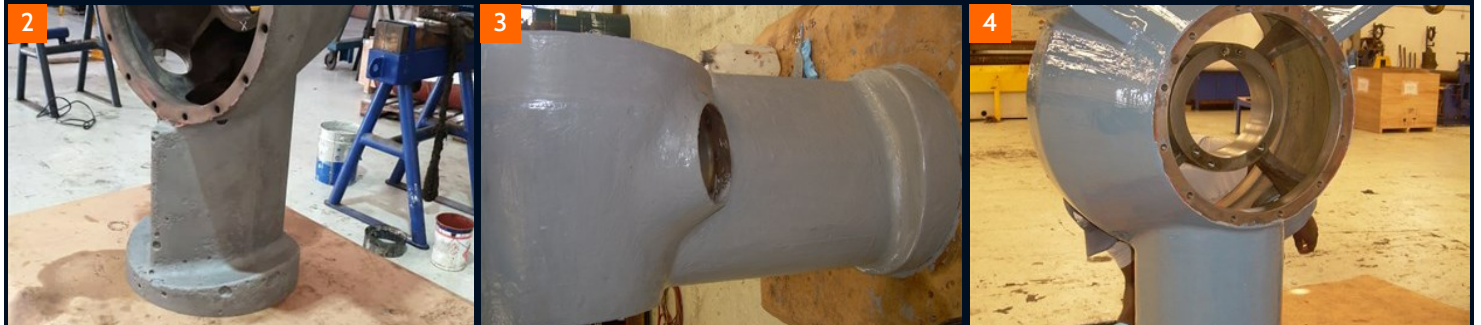
Heavily pitted and corroded on the out side of the thruster housing which would be costly and time-consuming to repair.

Stern Thruster for sea going vessel has a large degree of pitting due to erosion-corrosion by sea water.

1. Pitted Housing 2. After grid blast 3. after applying Belzona 1111 4. Final coat Belzona 1321

Application was carried out according to the KHIA Leaflet SOS-1.

Belzona 1111 (Super metal)

Belzona 1321 (Ceramic S-metal)
