# BELZONA SEALS FUEL TRANSPORT HOSE 66FT UNDERWATER

ID: 819

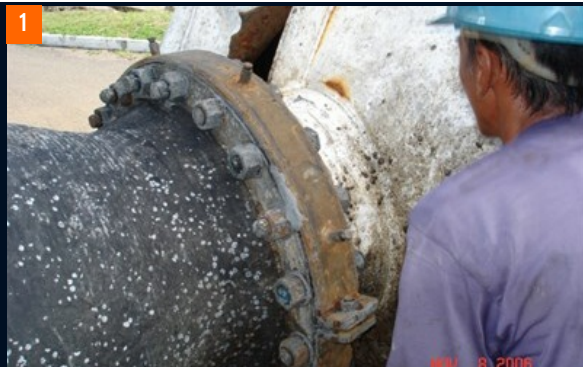
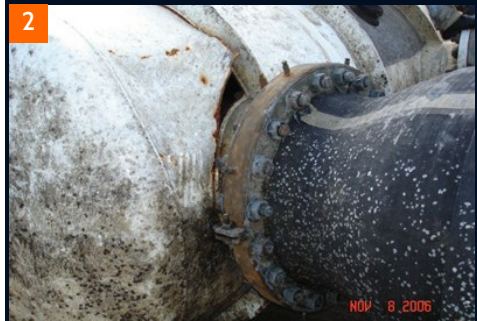
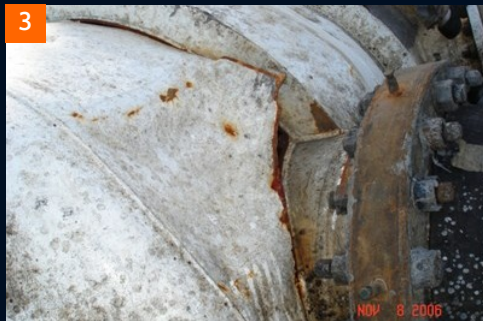
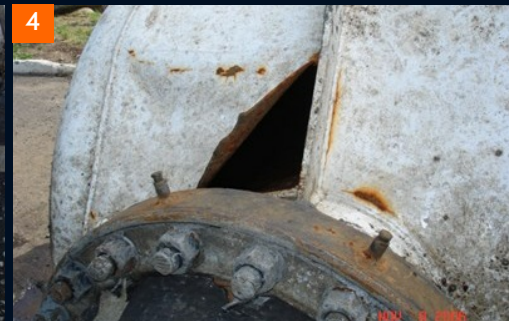
Accident caused leaks on the flange and bolt areas of the fuel transport hose. This posed a severe environmental hazard necessitating immediate action.

1. -4. The Flange brought on-shore. Note the clamp around flange circumference.

The application was carried out in accordance with Belzona Know-How System Leaflet SOS-20. A team of 15 divers sealed individual bolts whilst a clamp was sealed around the flange circumference using Belzona® 1161.

Belzona® 1161 provided the divers with a material that could stem the leak underwater averting a major environmental incident. The excellent adhesion and ease of use of the Belzona® 1161 underwater allowed effective repairs to be carried out, allowing oil transfer to be completed before recovering the hose for more permanent repair ashore
