# BELZONA 5892 REPAIRS A TANK IN BREWERY

ID: 8197

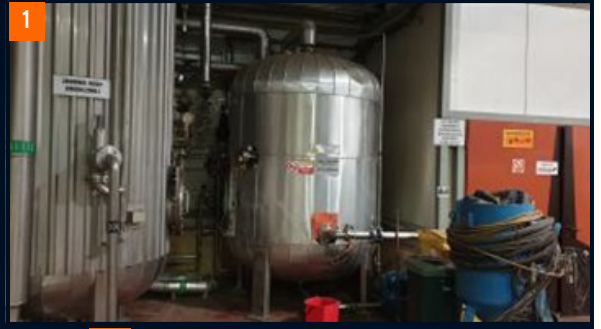
The tank in the brewery was suffering from pitting corrosion of the welds, stub pipes and general corrosion of the internal metal sheets.

1. Brewery Tank
2. Pitting Corrosion on the joints inside the tank.
3. Re profiling joints with Belzona 1111
4. Application of the Belzona 5892

Started out with grit blasting to prepare the surface. This was then followed by repairing the welds with Belzona 1111. The repairs of the connectors with Belzona 9341 used in conjunction with Belzona 1111. The 1st layer of Belzona 5892 at an average thickness about 250 µm. Application of the 2nd layer Belzona 5892 average thickness about 250 µm. Finally a thickness test was carried in line with the Belzona 5892 IFU. The application was carried out in accordance with Belzona System Leaflet TCC-03.
