# BELZONA 5892 PROTECTS CEMENT PLANT WALLS

ID: 8198

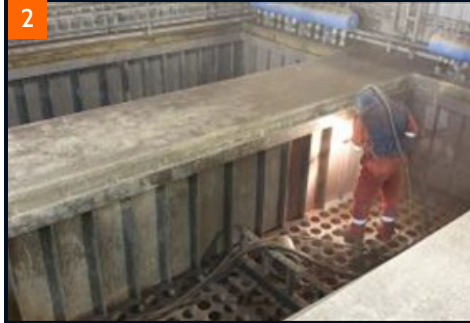
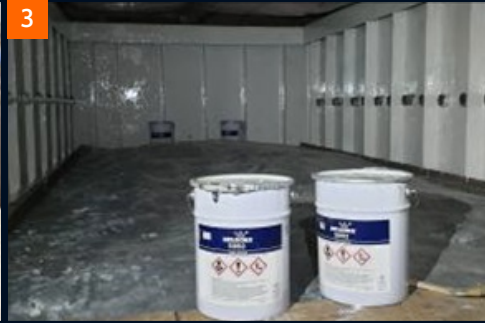
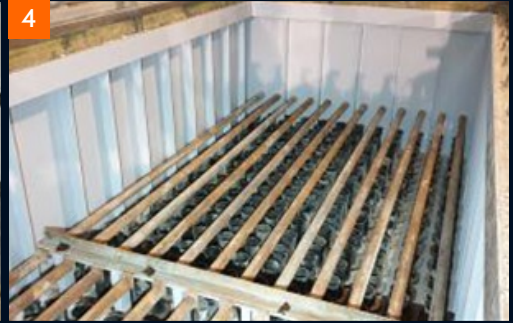
The temperature in the furnace bag filters has caused corrosion of the bag filter walls.

Damaged walls of the furnace bag filters on a Cement plant.

1. Oven bag filter before protection
2. Grit blasting filter surface
3. First Layer of Belzona 5892
4. Oven bag filter after 2nd Layer of Belzona 5892

Abrasive grit blasting, dust removal of wall surfaces and bag filter sieves. Then a Belzona 5892 two coat system was applied.
